HABS No. AZ-145-F

Phoenix Indian School, Hospital (Student Center)
Northeast Corner of Central Avenue and Indian School Rd.
Phoenix
Maricopa County
Arizona

HISTORIC AMERICAN BUILDINGS SURVEY

PHOENIX INDIAN SCHOOL, HOSPITAL (Student Center) HABS NO.: AZ-145-F

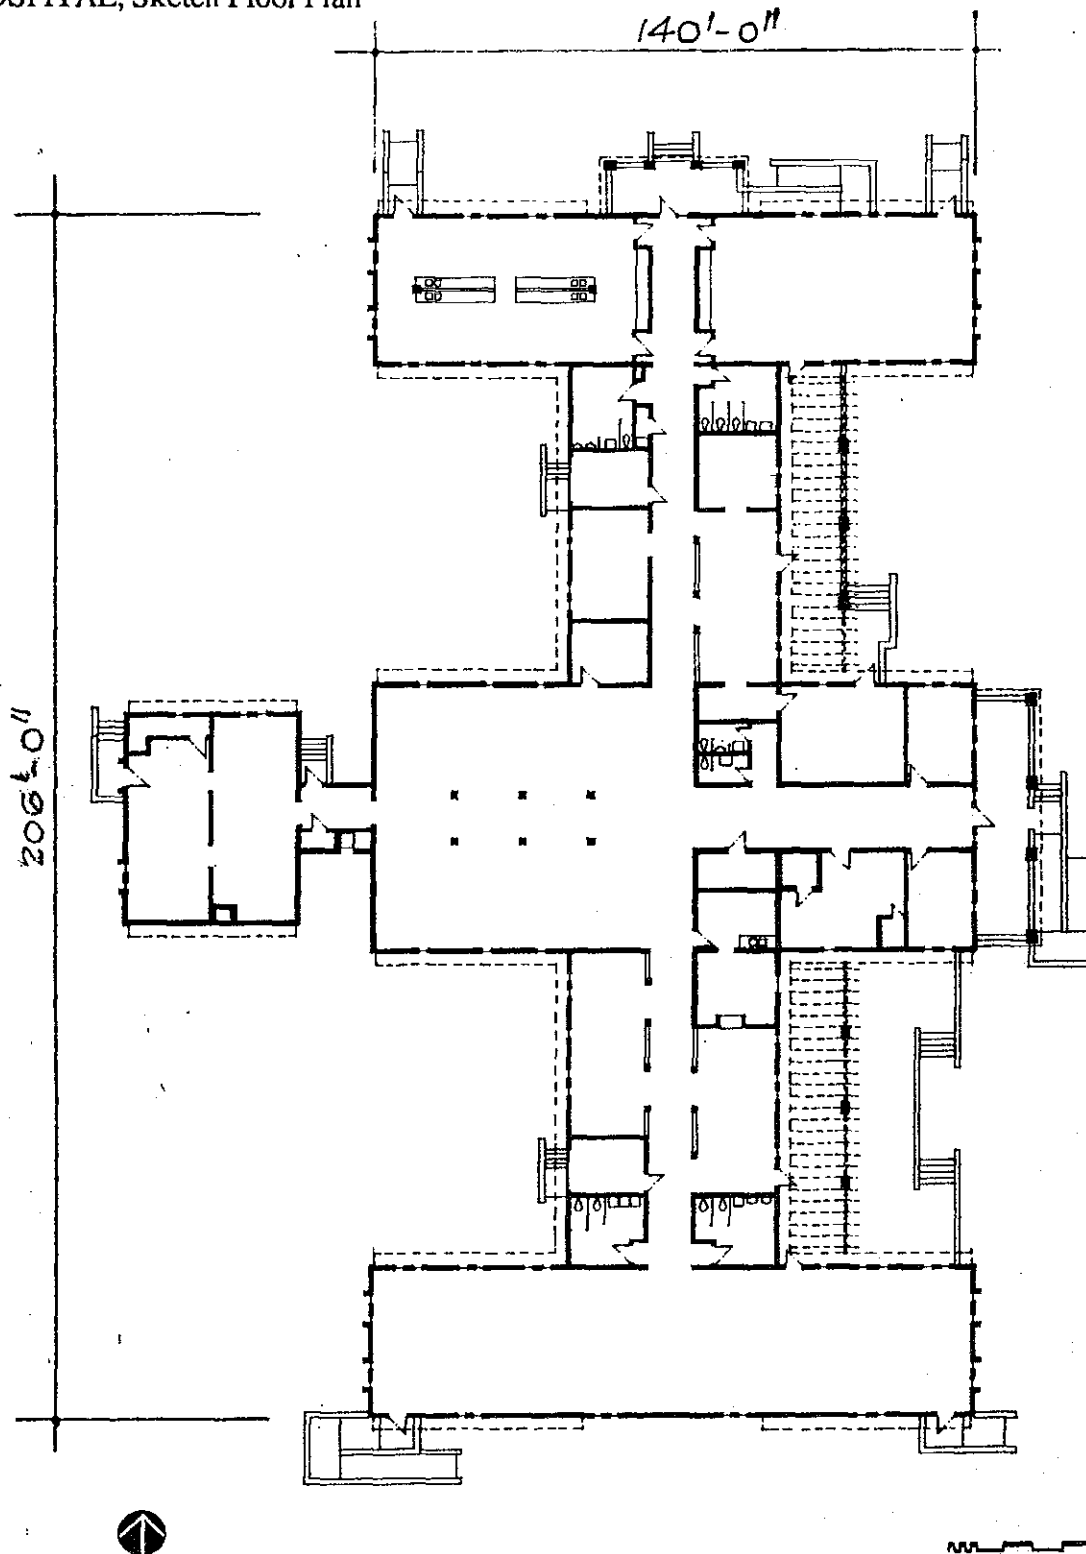
HOSPITAL, Sketch Floor Plan

The Hospital was a single story complex, 140' east-west x 206' north-south overall, formed of a larger central block, a rectangle running north-south, crossed by three smaller rectangular blocks running east-west, forming a double E in plan; the central east-west block, 140' x 46', was extended to the west by the addition of a smaller pavillion, 36' wide, connected to the central block by a narrow link; the east-west blocks to north and south of the central block were each 140' x 36'. Each block had a double-loaded central corridor; those to the north and south were patient wards, while the central block housed administrative, clinic and laboratory functions.

Originally, the interior of each block consisted of a wide central corridor flanked on either side by matching rows of rooms. The original disposition was preserved in part through the last alterations, although the removal of interior partitions, replacement of windows, floor and ceiling finishes, lighting fixtures, and so on, contributed to the disappearance of most of the original character of the interior. The alterations of 1973 were designed in the Facilities Management Section, Phoenix Area Office, Bureau of Indian Affairs.
